02/05/26 mbrxigrt61037_35.ppp_defaut-4644d-15_7-stp

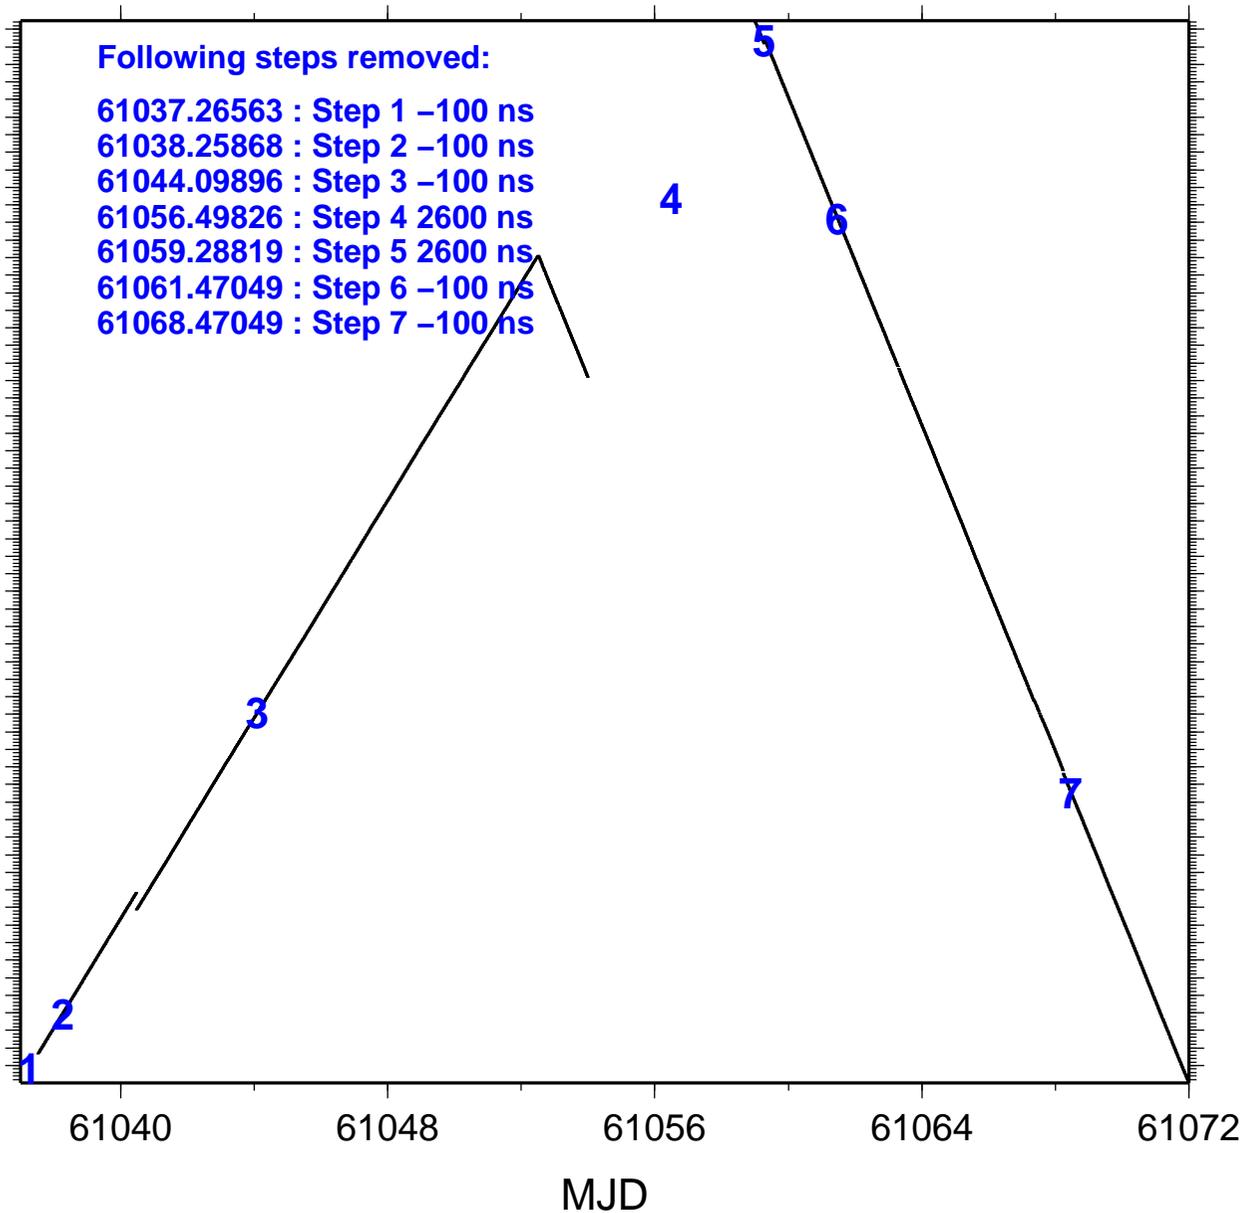
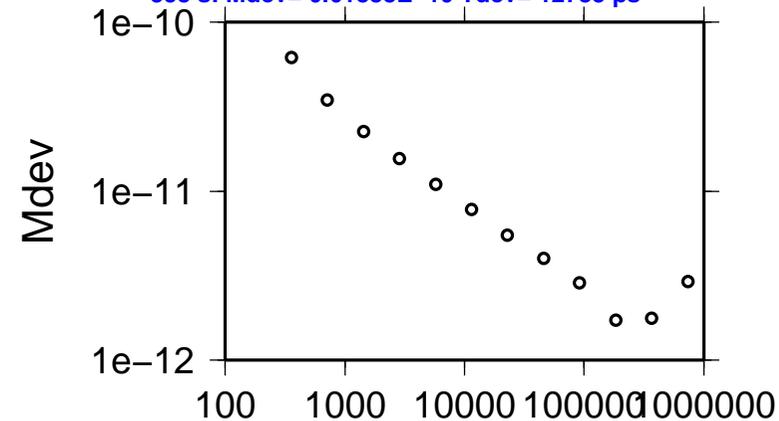
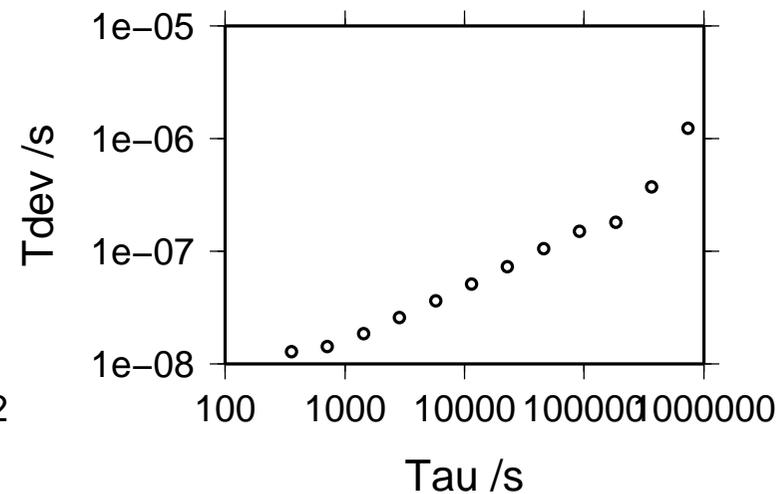
732671 s: Mdev= 0.29200E-11 Tdev= 1235200 ps
 366336 s: Mdev= 0.17644E-11 Tdev= 373170 ps
 183168 s: Mdev= 0.17192E-11 Tdev= 181800 ps
 91584 s: Mdev= 0.28560E-11 Tdev= 151020 ps
 45792 s: Mdev= 0.39954E-11 Tdev= 105630 ps
 22896 s: Mdev= 0.55021E-11 Tdev= 72732 ps
 11448 s: Mdev= 0.77742E-11 Tdev= 51383 ps
 5724 s: Mdev= 0.10979E-10 Tdev= 36282 ps
 2862 s: Mdev= 0.15588E-10 Tdev= 25757 ps
 1431 s: Mdev= 0.22532E-10 Tdev= 18616 ps
 716 s: Mdev= 0.34556E-10 Tdev= 14275 ps
 358 s: Mdev= 0.61888E-10 Tdev= 12783 ps

61037.26563 : Step 1 -100 ns
 61038.25868 : Step 2 -100 ns
 61044.09896 : Step 3 -100 ns
 61056.49826 : Step 4 2600 ns
 61059.28819 : Step 5 2600 ns
 61061.47049 : Step 6 -100 ns
 61068.47049 : Step 7 -100 ns
